Solicitation Number	IFB 23019-JD
Addendum #	1
Date Issued	03/27/2023
Procurement Officer	James de Luca, CPPO
Phone	843-953-6861
E-Mail Address	jdeluca@citadel.edu

SOLICITATION TITLE: IFB 23019-JD 301-308 Mims Ave. Window, Gutters & Downspout Replacement.

Reference: **Asbestos and Lead-Based Paint Assessment Report**
301-304 Mims Avenue and 305-308 Mims Avenue (Two Structures)
The Citadel
Charleston, South Carolina
S&ME Project No. 22130686

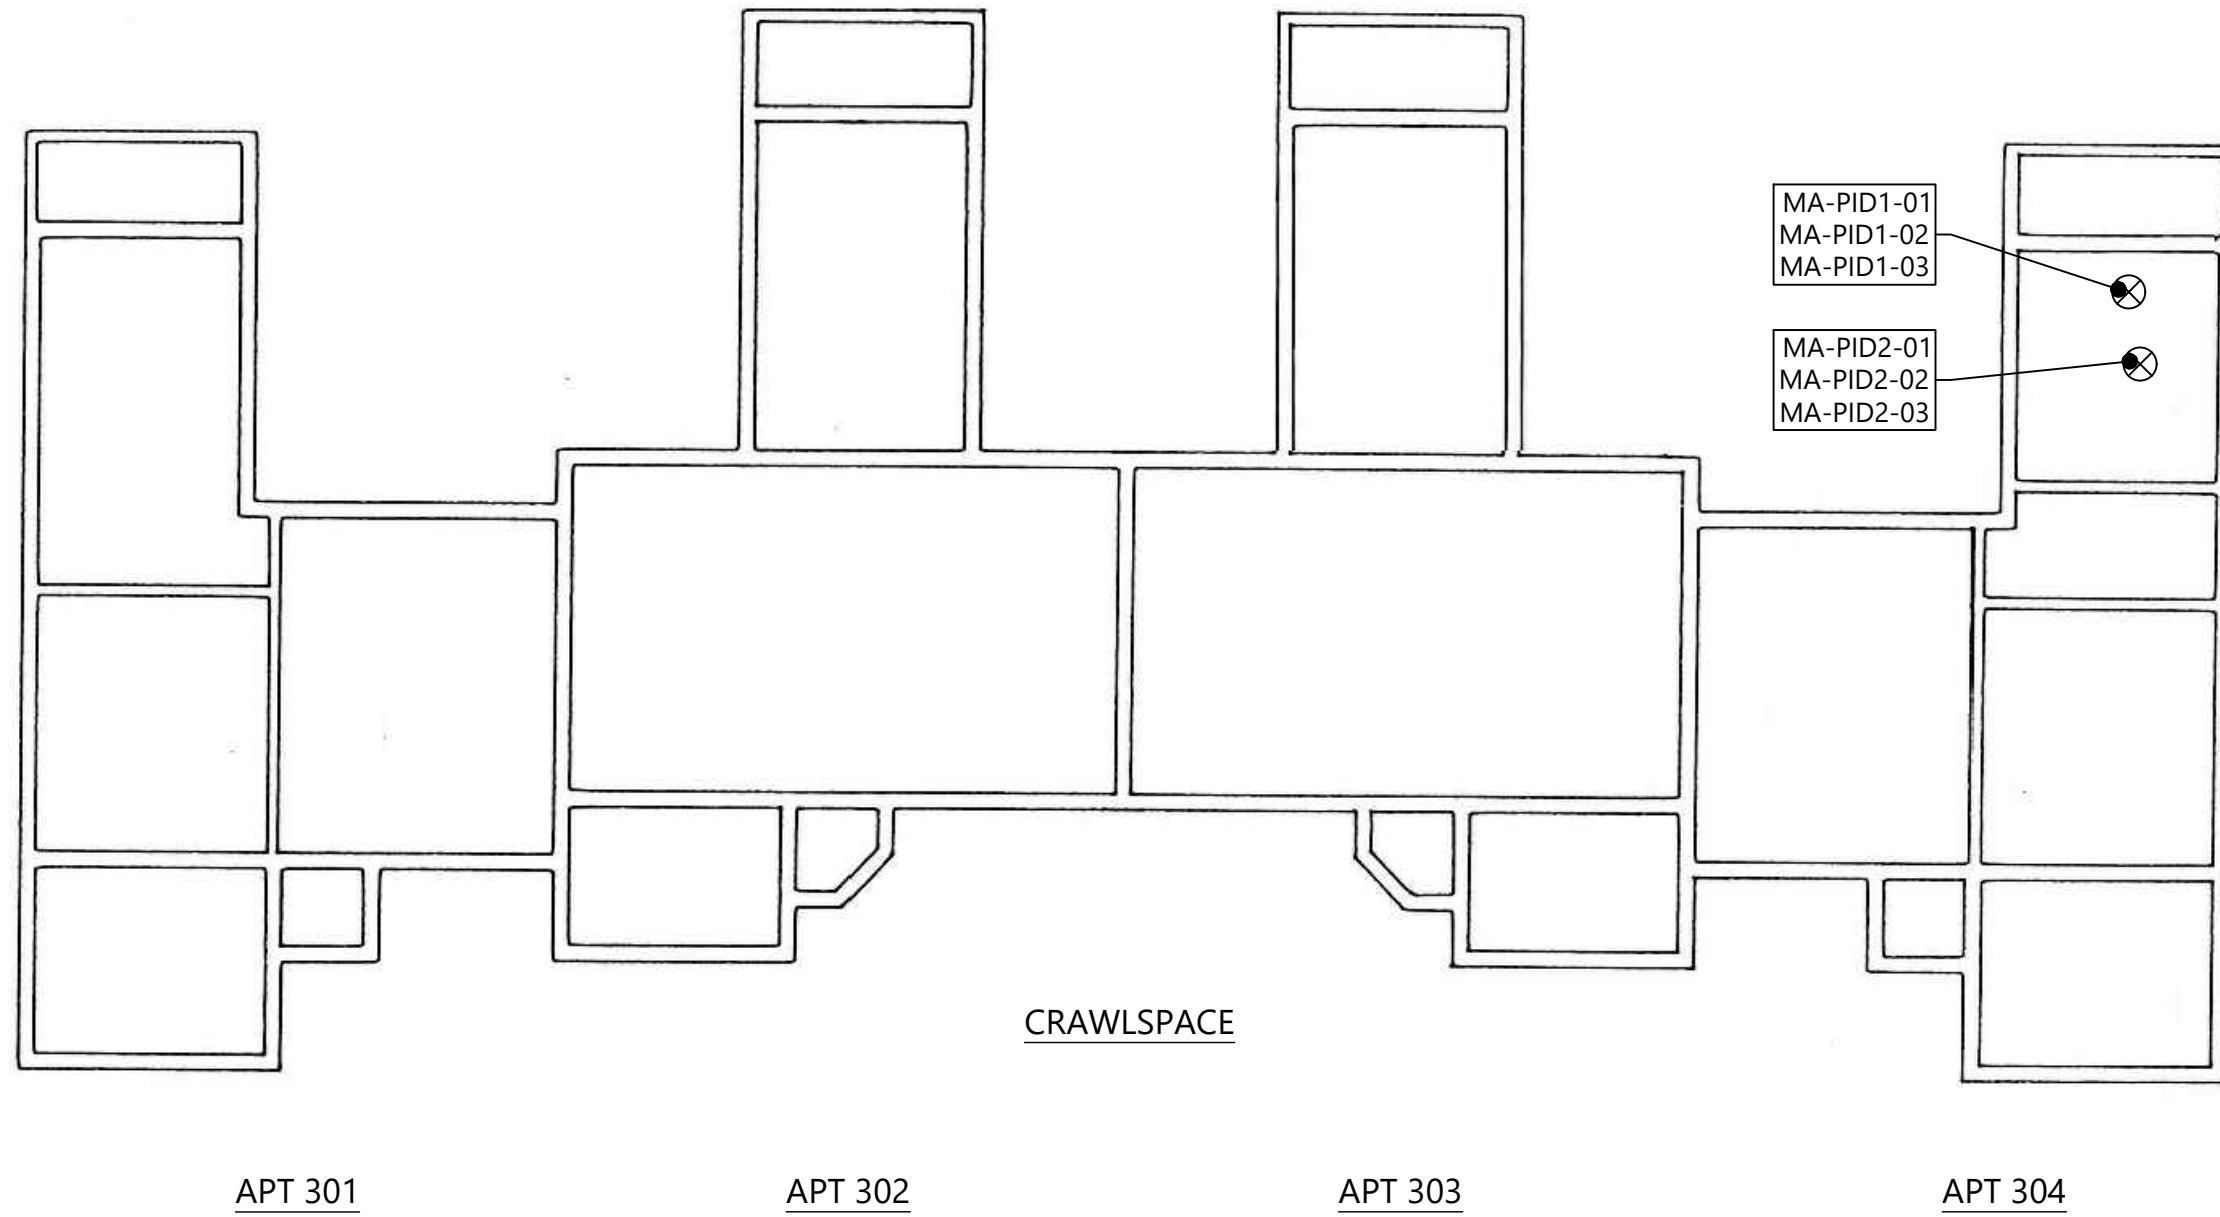
1

- INTERIOR DOOR CASINGS (WHITE PAINT ON WOOD) - INTACT CONDITION
- INTERIOR WINDOW CASINGS, SILLS, APRONS, AND SASHES (WHITE PAINT ON WOOD) - INTACT CONDITION
- INTERIOR BASEBOARDS (WHITE PAINT ON WOOD) - INTACT CONDITION
- INTERIOR CEILING TRIM (WHITE PAINT ON WOOD) - INTACT CONDITION
- INTERIOR STAIR RISERS AND STRINGERS (WHITE PAINT ON WOOD) - INTACT CONDITION
- EXTERIOR TRIM (GREEN PAINT ON WOOD) - INTACT CONDITION

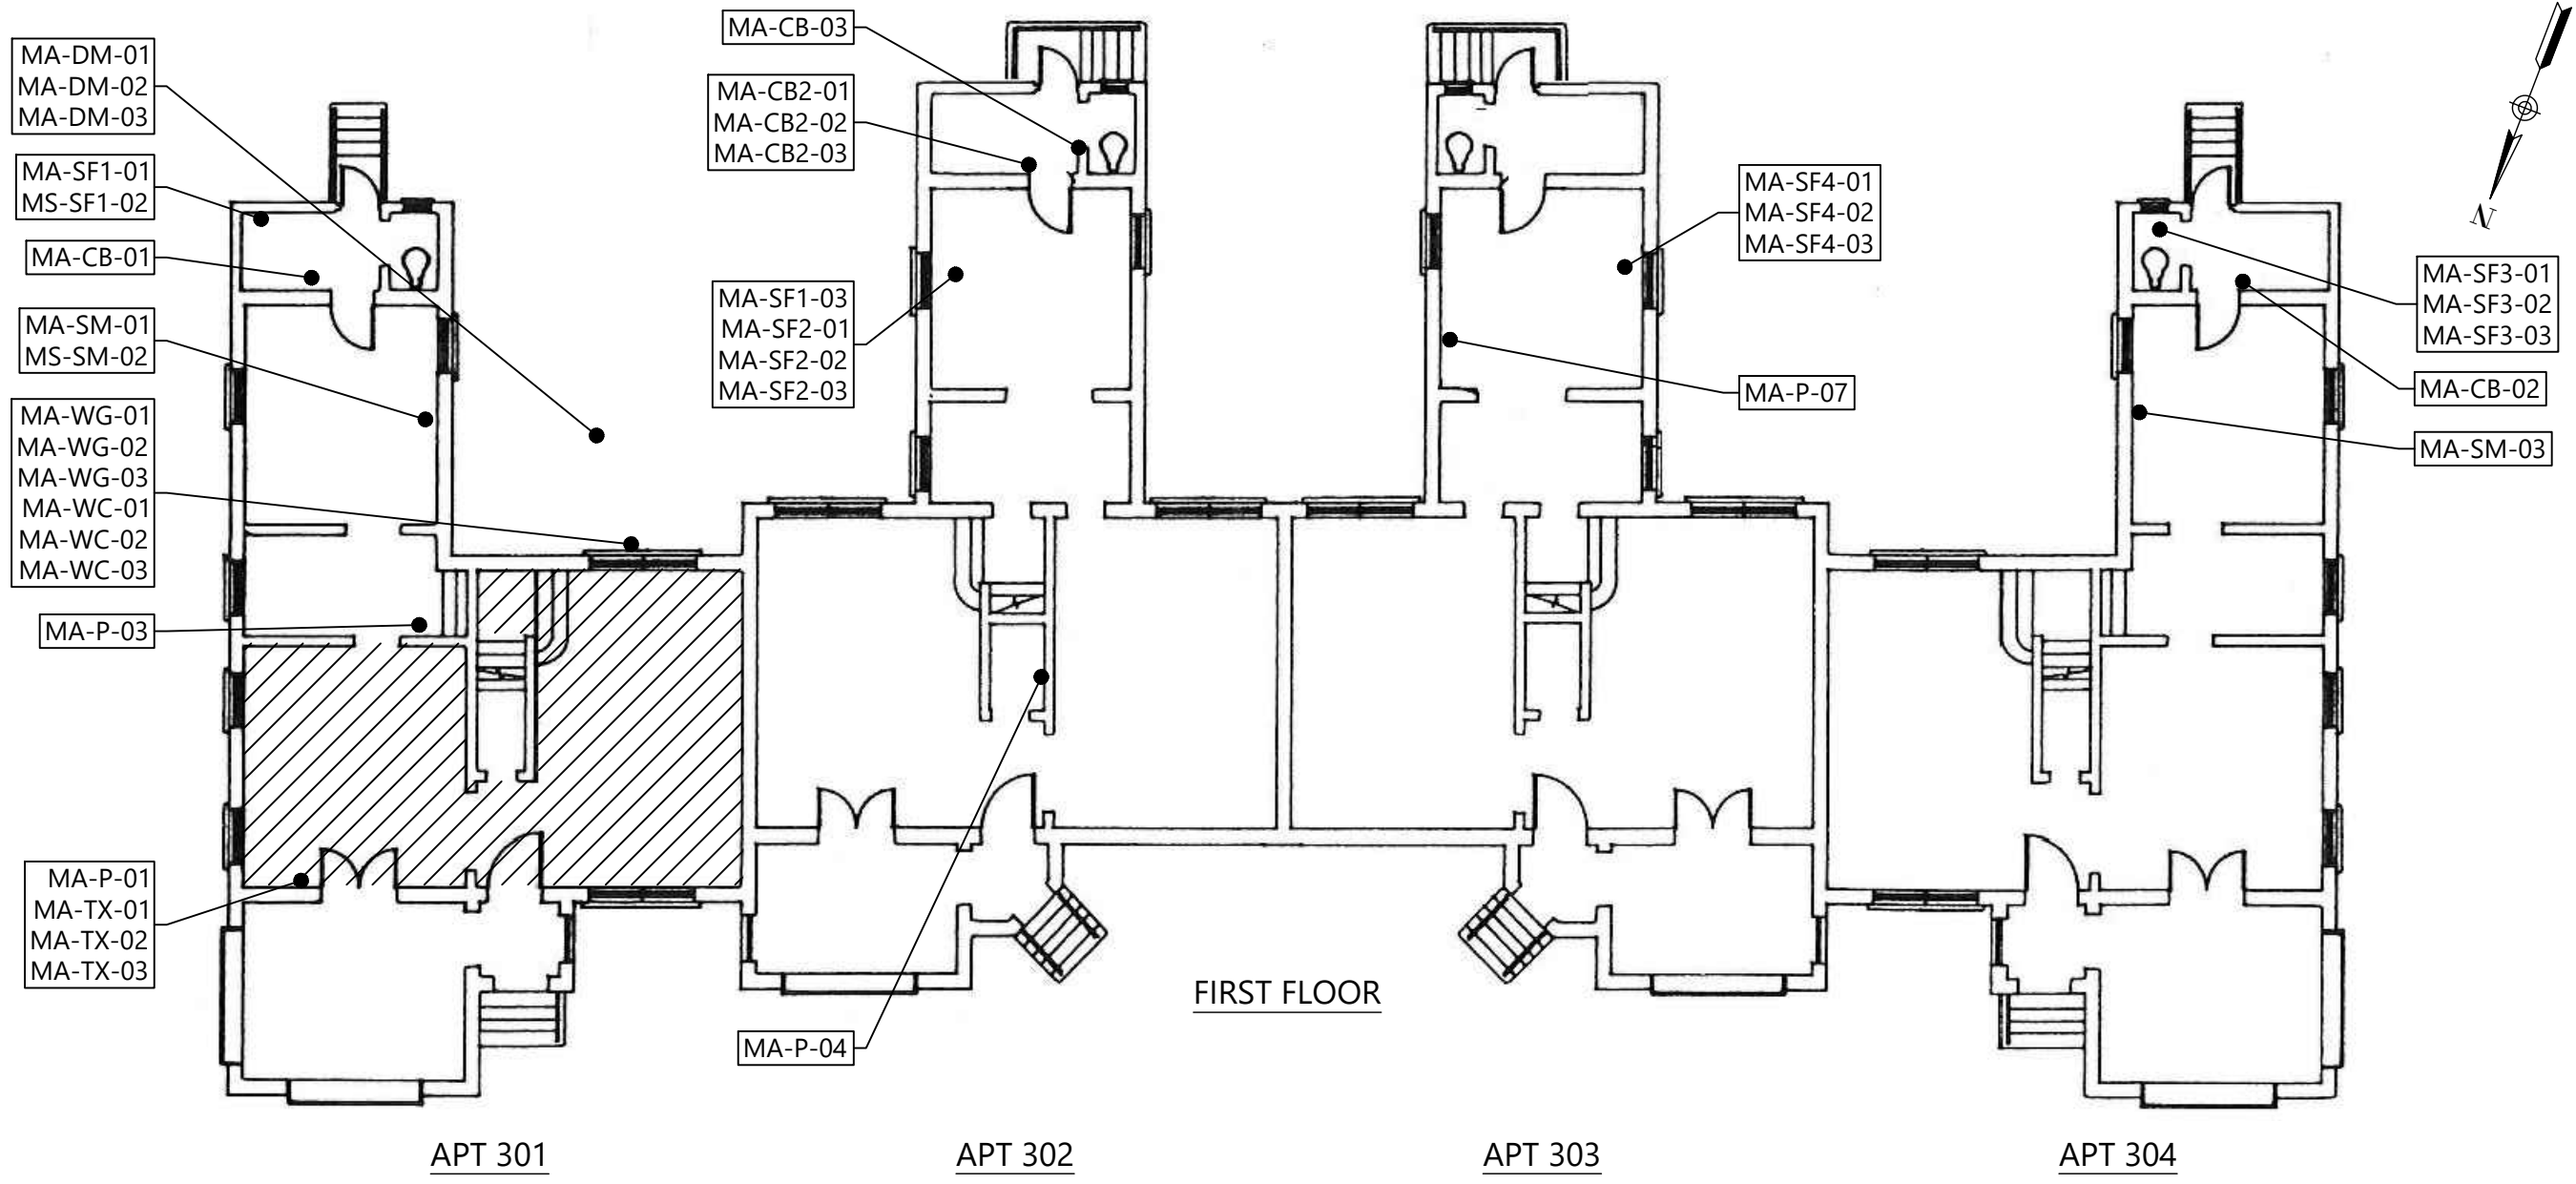
ASBESTOS CONTAINING MATERIALS

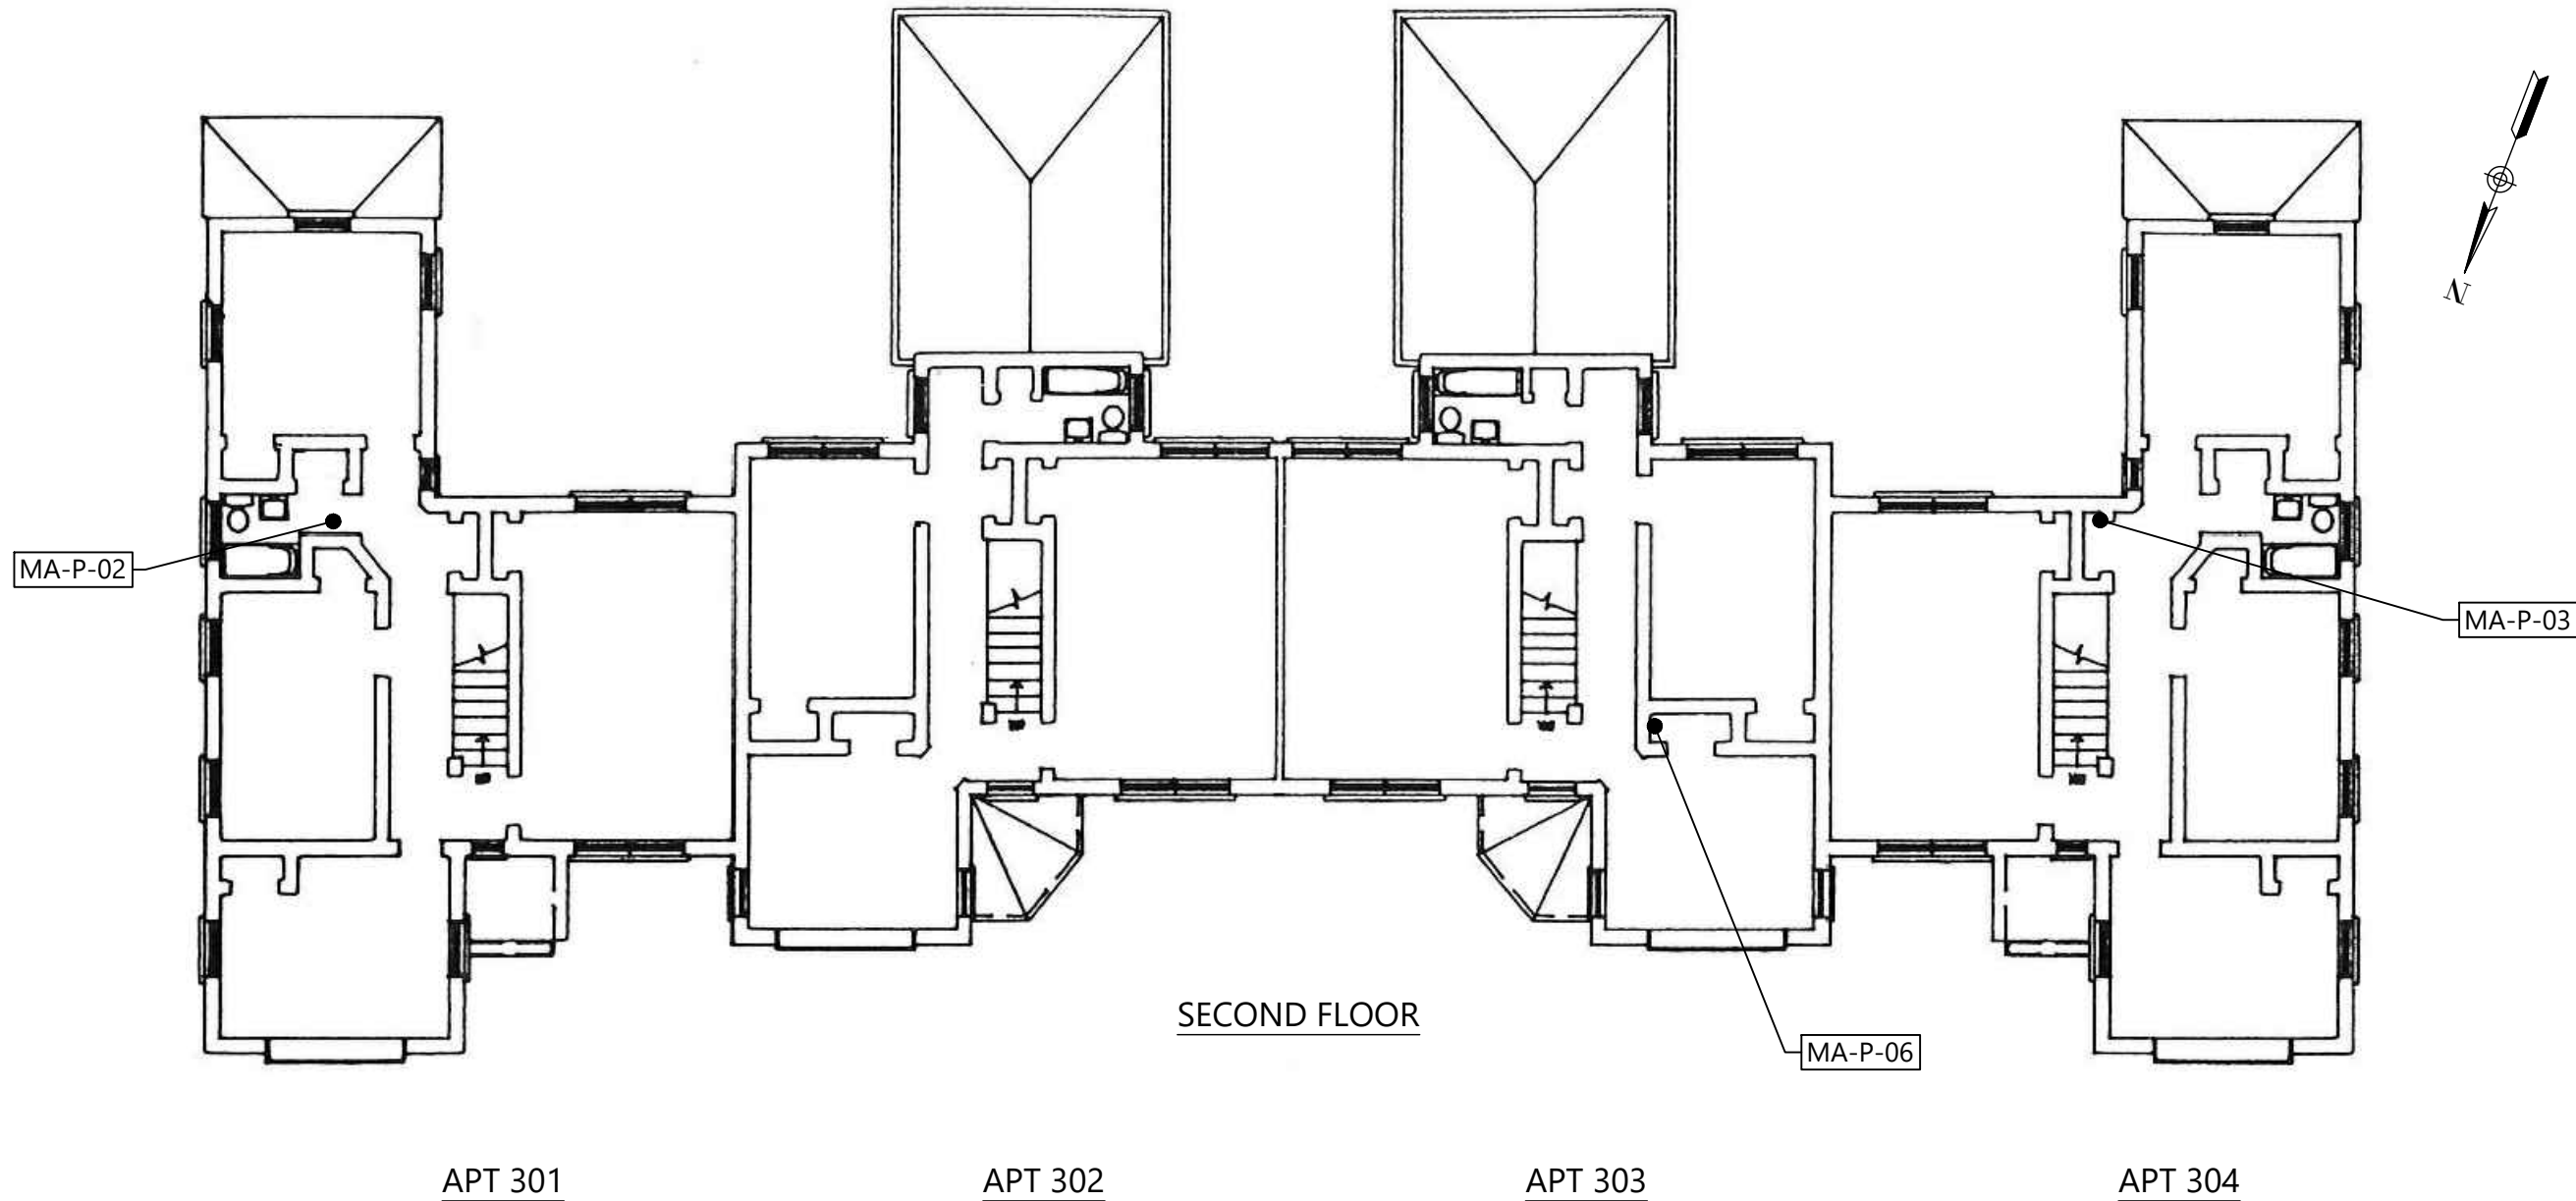
- INTERIOR DOOR CASINGS (WHITE PAINT ON WOOD) - INTACT CONDITION
- INTERIOR WINDOW CASINGS, SILLS, APRONS, AND SASHES (WHITE PAINT ON WOOD) - INTACT CONDITION
- INTERIOR BASEBOARDS (WHITE PAINT ON WOOD) - INTACT CONDITION
- INTERIOR CEILING TRIM (WHITE PAINT ON WOOD) - INTACT CONDITION
- INTERIOR STAIR RISERS AND STRINGERS (WHITE PAINT ON WOOD) - INTACT CONDITION
- BATHROOM CABINETRY (WHITE PAINT ON WOOD) - INTACT CONDITION
- GLAZING ON PORCELAIN BATHTUBS - INTACT CONDITION
- GLAZING ON CERAMIC WALL TILE IN BATHROOMS - INTACT CONDITION

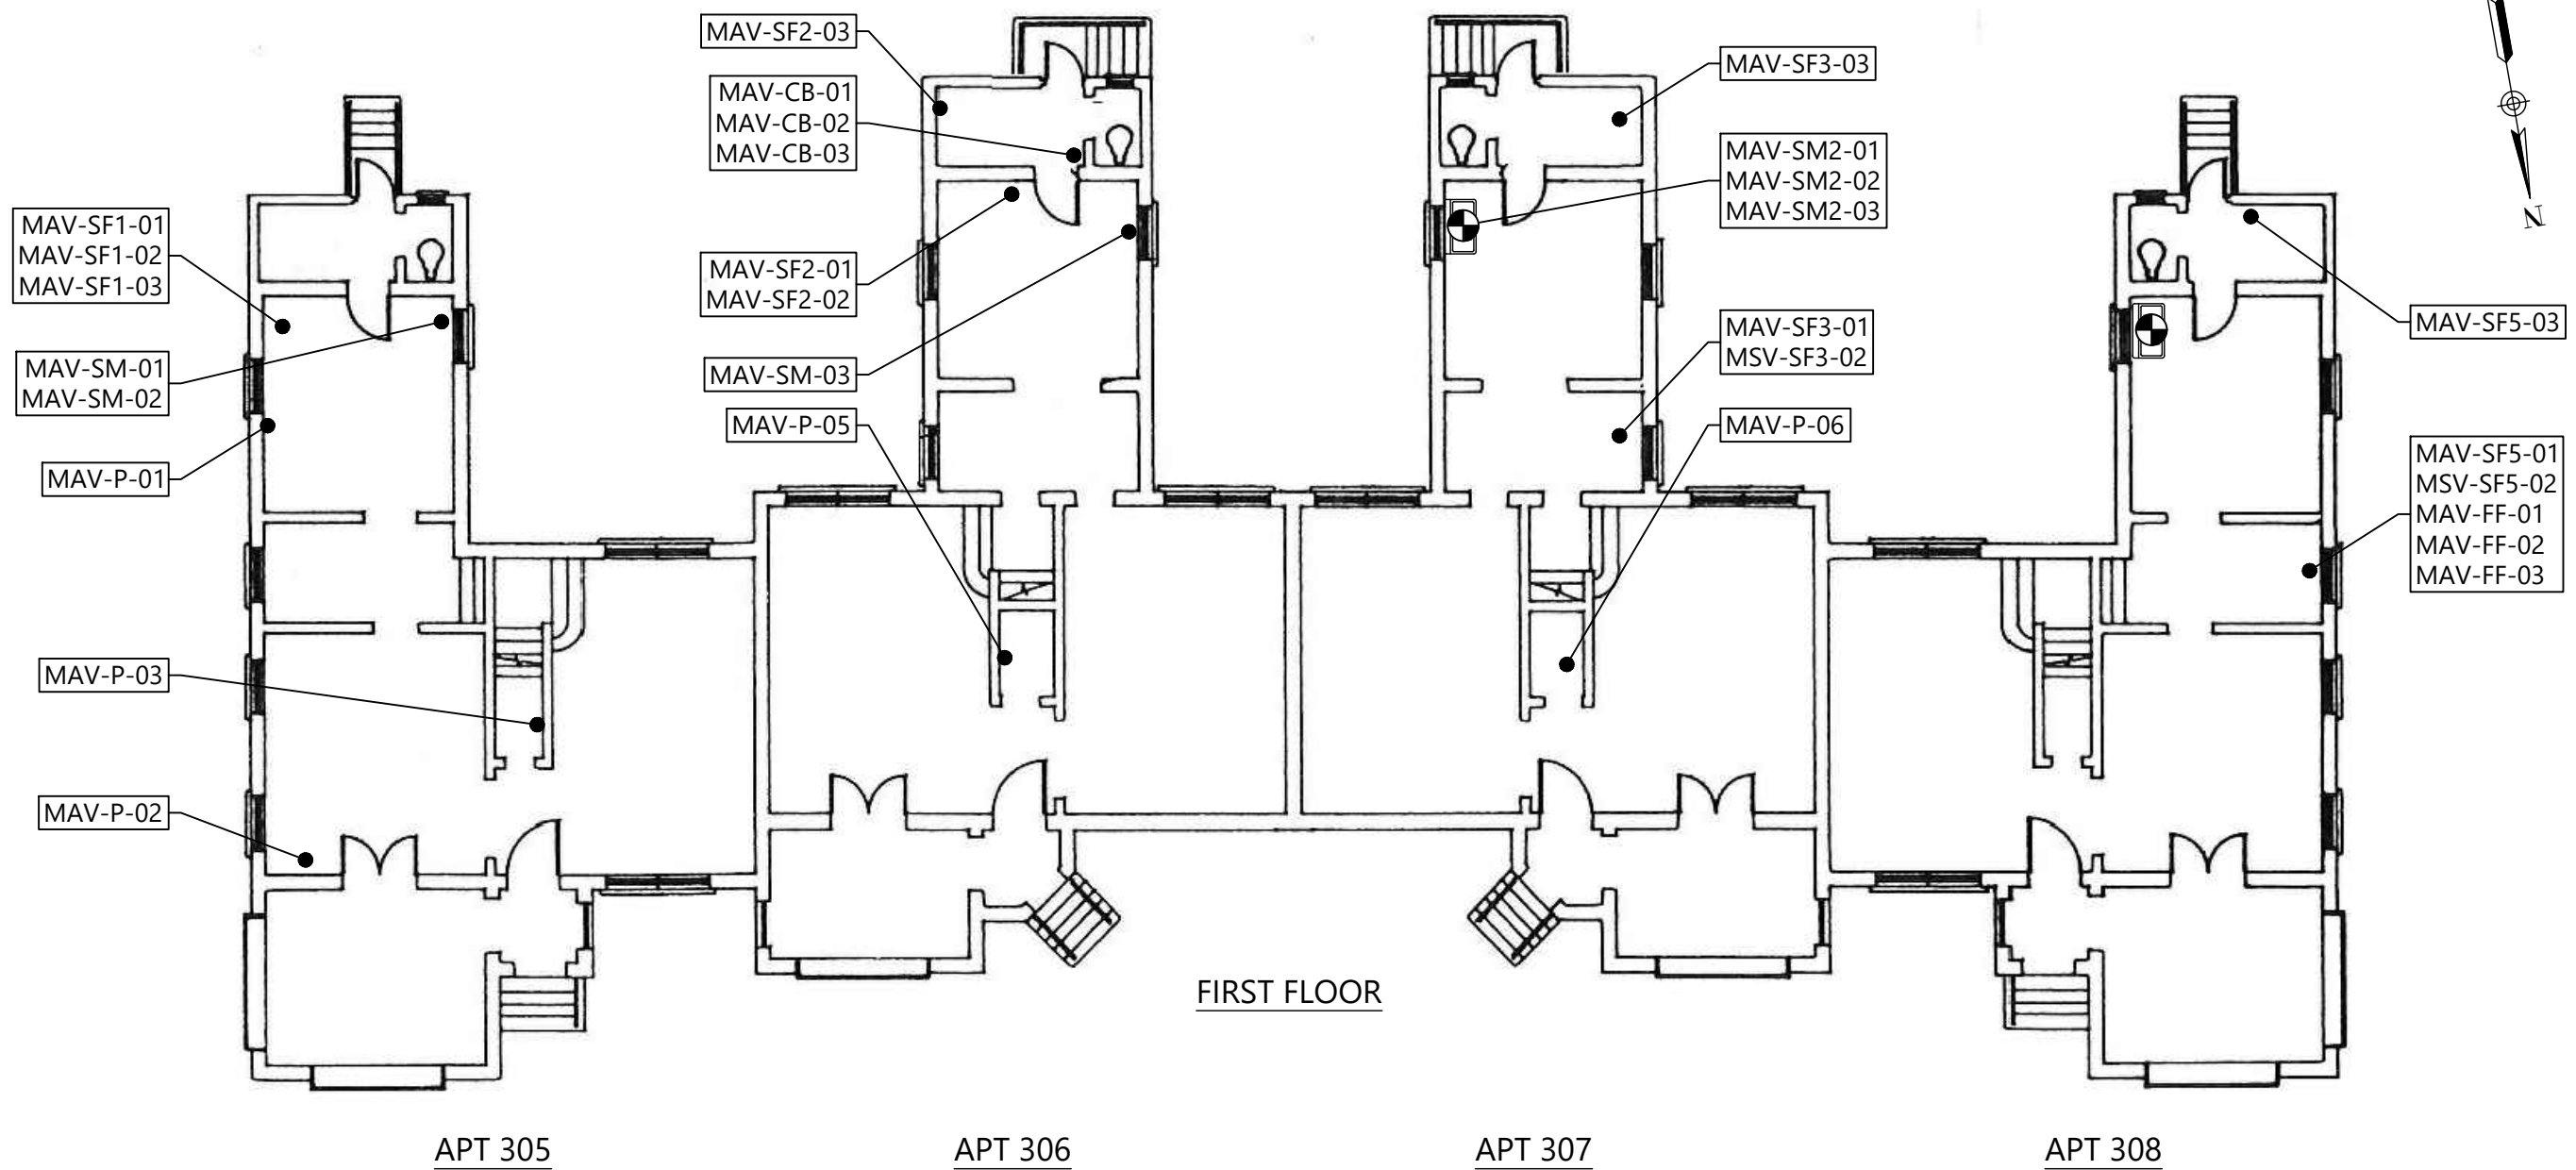
5

⊕ MASTIC (WHITE) ASSOCIATED WITH STAINLESS STEEL SINKS APPROXIMATELY 12 SQUARE FEET

- INTERIOR DOOR CASINGS (WHITE PAINT ON WOOD) - INTACT CONDITION
- INTERIOR WINDOW CASINGS, SILLS, APRONS, AND SASHES (WHITE PAINT ON WOOD) - INTACT CONDITION
- INTERIOR BASEBOARDS (WHITE PAINT ON WOOD) - INTACT CONDITION
- INTERIOR CEILING TRIM (WHITE PAINT ON WOOD) - INTACT CONDITION
- INTERIOR STAIR RISERS AND STRINGERS (WHITE PAINT ON WOOD) - INTACT CONDITION
- EXTERIOR DOORS AND DOOR CASINGS (GREEN PAINT ON WOOD) - INTACT CONDITION
- EXTERIOR CEILING AND TRIM (GREEN PAINT ON WOOD) - INTACT CONDITION
- EXTERIOR HANDRAIL (GREEN PAINT ON METAL) - INTACT CONDITION

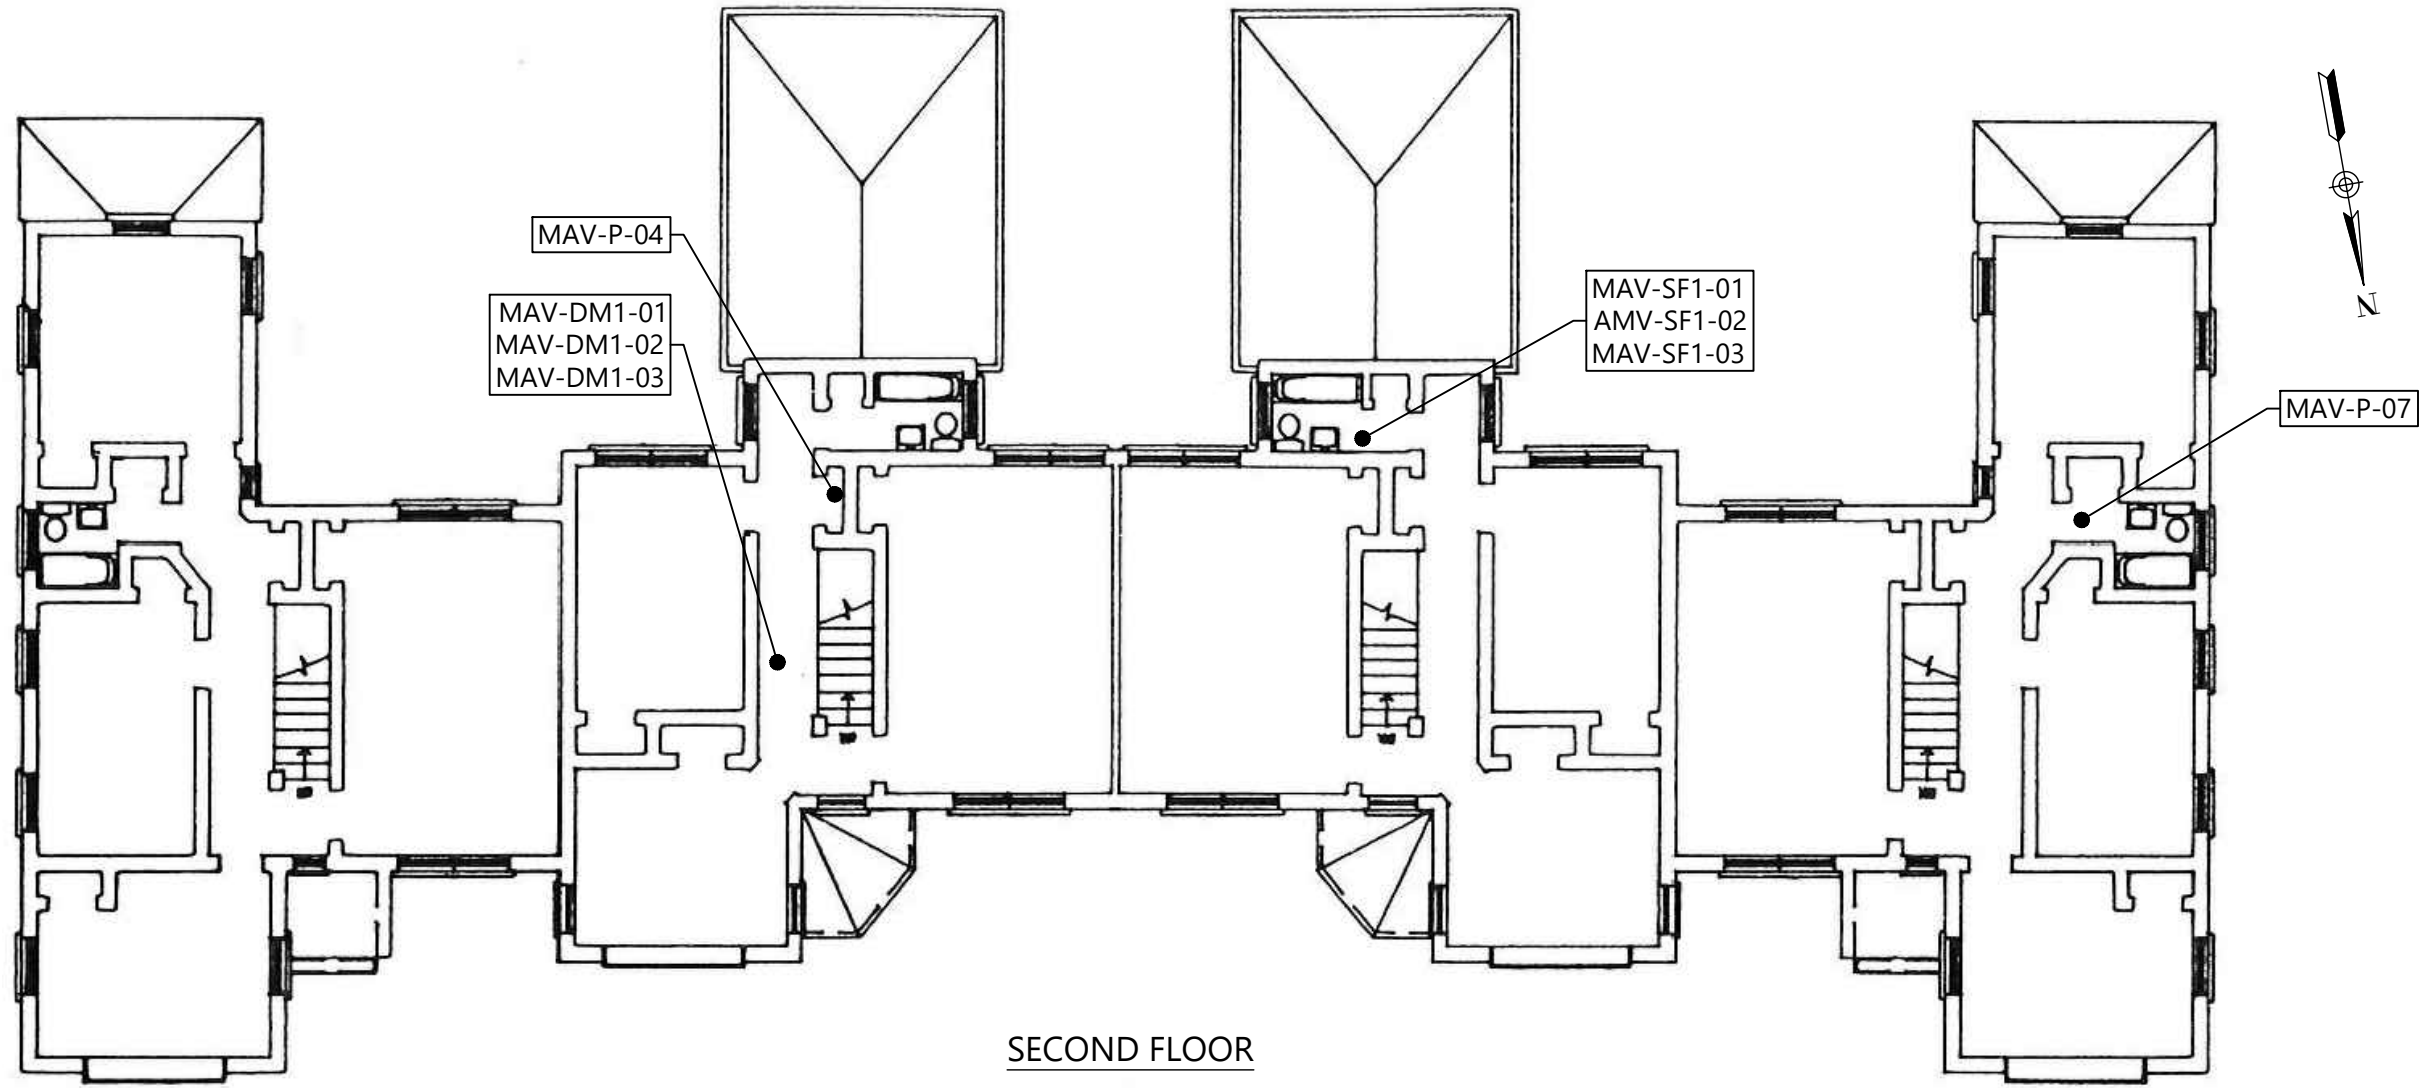
- INTERIOR DOOR CASINGS (WHITE PAINT ON WOOD) - INTACT CONDITION
- INTERIOR WINDOW CASINGS, SILLS, APRONS, AND SASHES (WHITE PAINT ON WOOD) - INTACT CONDITION
- INTERIOR BASEBOARDS (WHITE PAINT ON WOOD) - INTACT CONDITION
- INTERIOR STAIR RISERS AND STRINGERS (WHITE PAINT ON WOOD) - INTACT CONDITION
- GLAZING ON CERAMIC WALL TILE IN BATHROOMS - INTACT CONDITION
- GLAZING ON PORCELAIN BATHTUBS - INTACT CONDITION
- BATHROOM CABINETRY (WHITE PAINT ON WOOD) - INTACT CONDITION
- INTERIOR CEILING TRIM (WHITE PAINT ON WOOD) - INTACT CONDITION
